DEFENSE ACQUISITIONS

Army Purchased Truck Trailers That Cannot Be Used as Planned

GAO/NSIAD-00-15

October 27, 1999

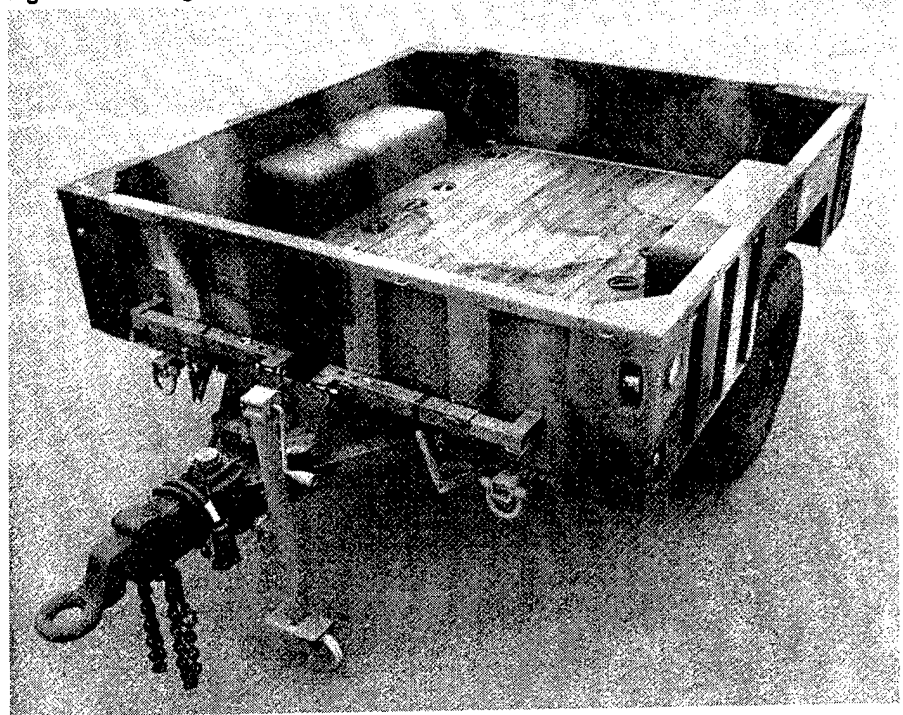
Figure 1: The High Mobility Cargo Trailer

The new trailer (see fig. 1) was designed to be compatible with both the light and heavy High Mobility Multipurpose Wheeled Vehicles. Differences in the two trucks required that two cargo versions of the trailers be produced. The light cargo trailer was to carry at least 1,500 pounds and the heavy cargo trailer was to carry at least 2,500 pounds. The new trailers also included a chassis version that was to carry at least 2,700 pounds. The Army required the trailers to have the same track width and tires as the truck and inertia brakes, called surge brakes, which are actuated by forces between the tow hitch of the truck and the drawbar of the trailer. The trailer was to be capable of being towed at speeds up to 20 miles per hour cross-country, 35 miles per hour on secondary roads, and 55 miles per hour on primary roads.
